Identification of the Type and Quality of Gloucester Harbor Coastal and Seafloor Habitats: Synthesis of Harbor and Regional Studies

Anthony R. Wilbur

Massachusetts Office of Coastal Zone Management, Boston, MA

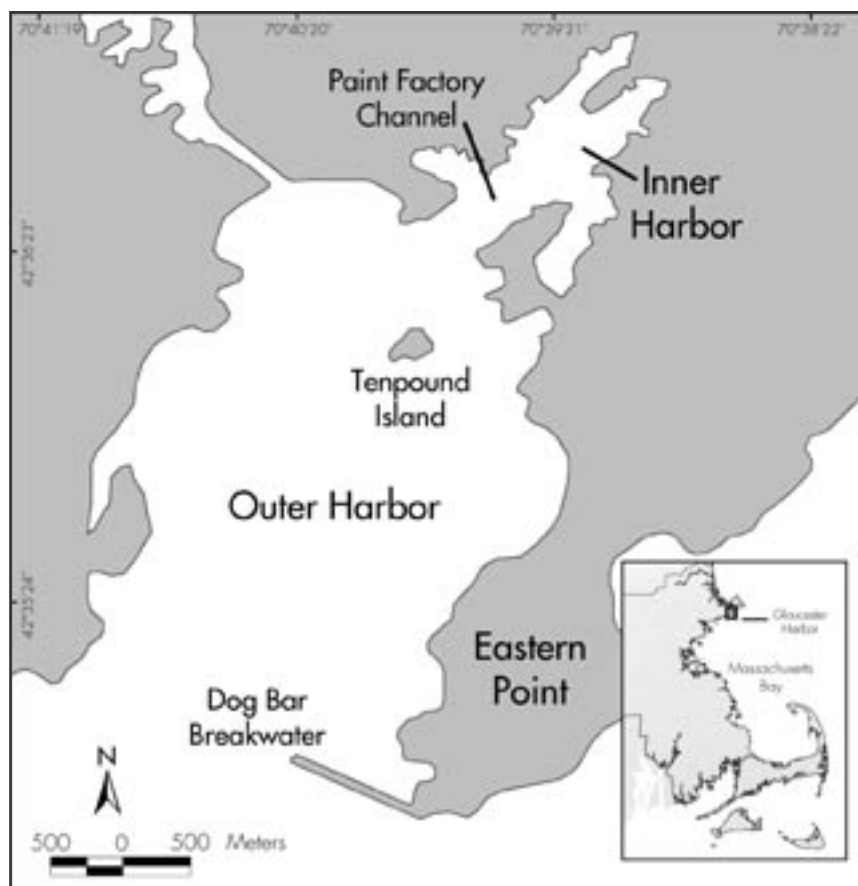
FIGURE 5.1 Landmarks and geographic features in Gloucester Harbor.

Gloucester Harbor (Figure 5.1) was investigated by a series of surveys to characterize fisheries resources and benthic habitats (MCZM 2001). The surveys were not intended to comprehensively describe seafloor habitat; however, substantial geographic areas of the seafloor environment were investigated, analyzed, and described. Existing statewide and regional assessments provided baseline conditions and complimentary information on coastal habitats, sea-

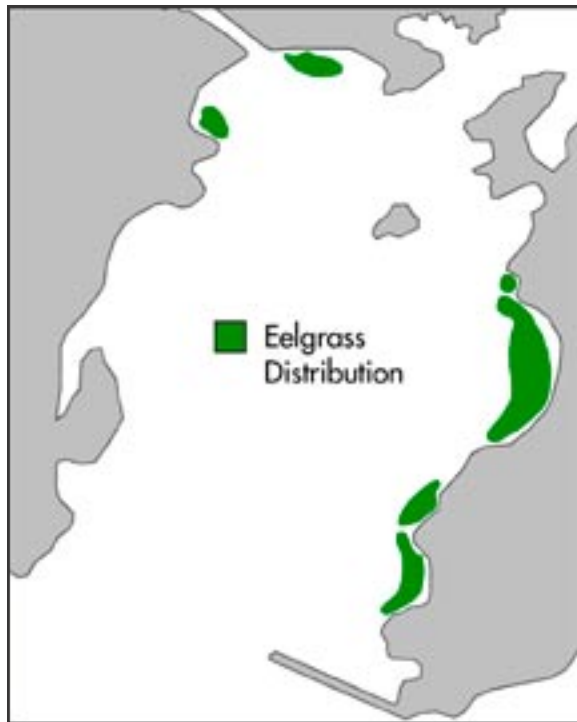
FIGURE 5.3 Distribution of eelgrass (*Zostera marina*) in Gloucester Harbor (eelgrass map produced from 1995 aerial photography and field verification; C. Costello personal communication; www.state.ma.us/mgis/massgis.htm).

that supports diverse floral and faunal assemblages, absorbs nutrients, stabilizes sediments, and provides detrital biomass for lower trophic levels (see Stephan and Bigford 1997 and Fonseca et al. 1998 for review). Wasting disease (*Labyrinthula* spp.) decimated North Atlantic eelgrass populations during the early 1930s, including populations in Gloucester Harbor. The loss of eelgrass substantially affected wildlife resources (e.g., avifauna foraging habitat) (Addy and Aylward 1944; Dexter 1985). Eelgrass populations recovered in Gloucester Harbor and Cape Ann waters (Addy and Aylward 1944; Dexter 1985), and distribution has remained stable (Buchsbaum personal communication). The 1995 DEP survey showed that Gloucester Harbor contained five discrete eelgrass beds in the outer harbor (Figure 5.3).
